ZOO / Wildlife Park

Customer: Tanganyika Wildlife Park, Wichita, KS

Application: Jackass Penguin Exhibit

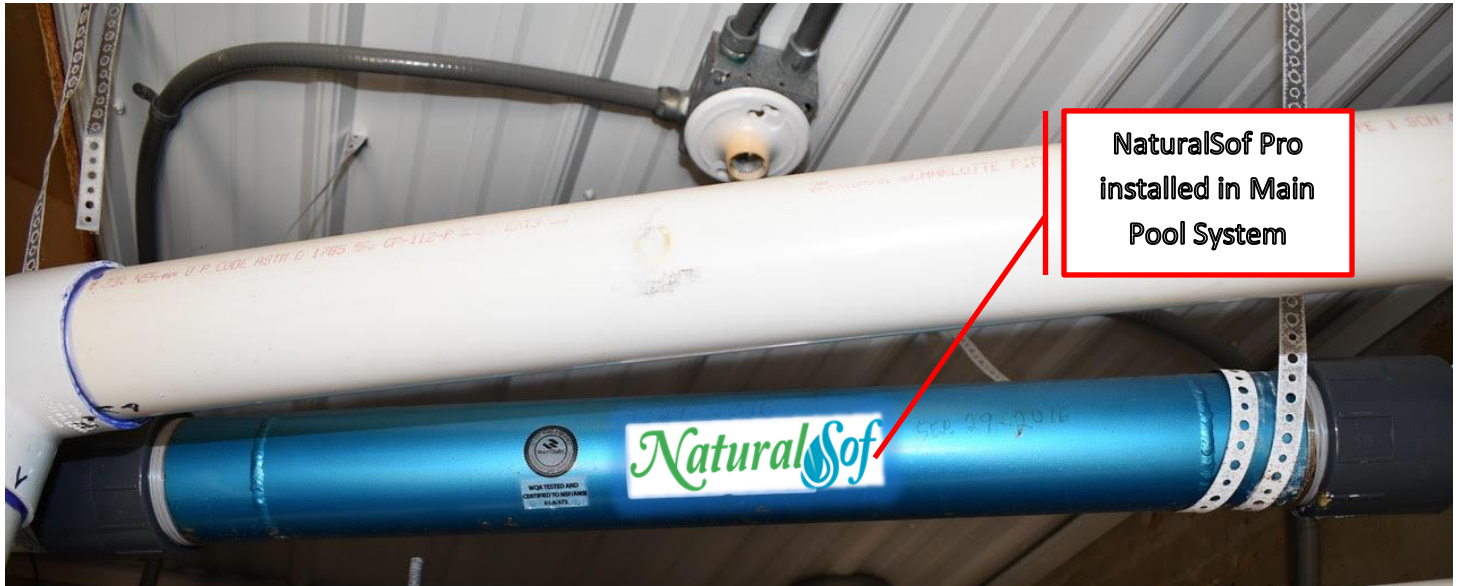
NaturalSof Pro
installed in Main
Pool System

The Solution: In 2015, the park installed a NaturalSof NS96 3" scale preventer in the main pool plumbing system (see next page...)
